GENERATOR FIRE:

the experience, the repair, and the prevention

Ed Gurdjian and Carol Maxwell
RvTechStop.com October 2004

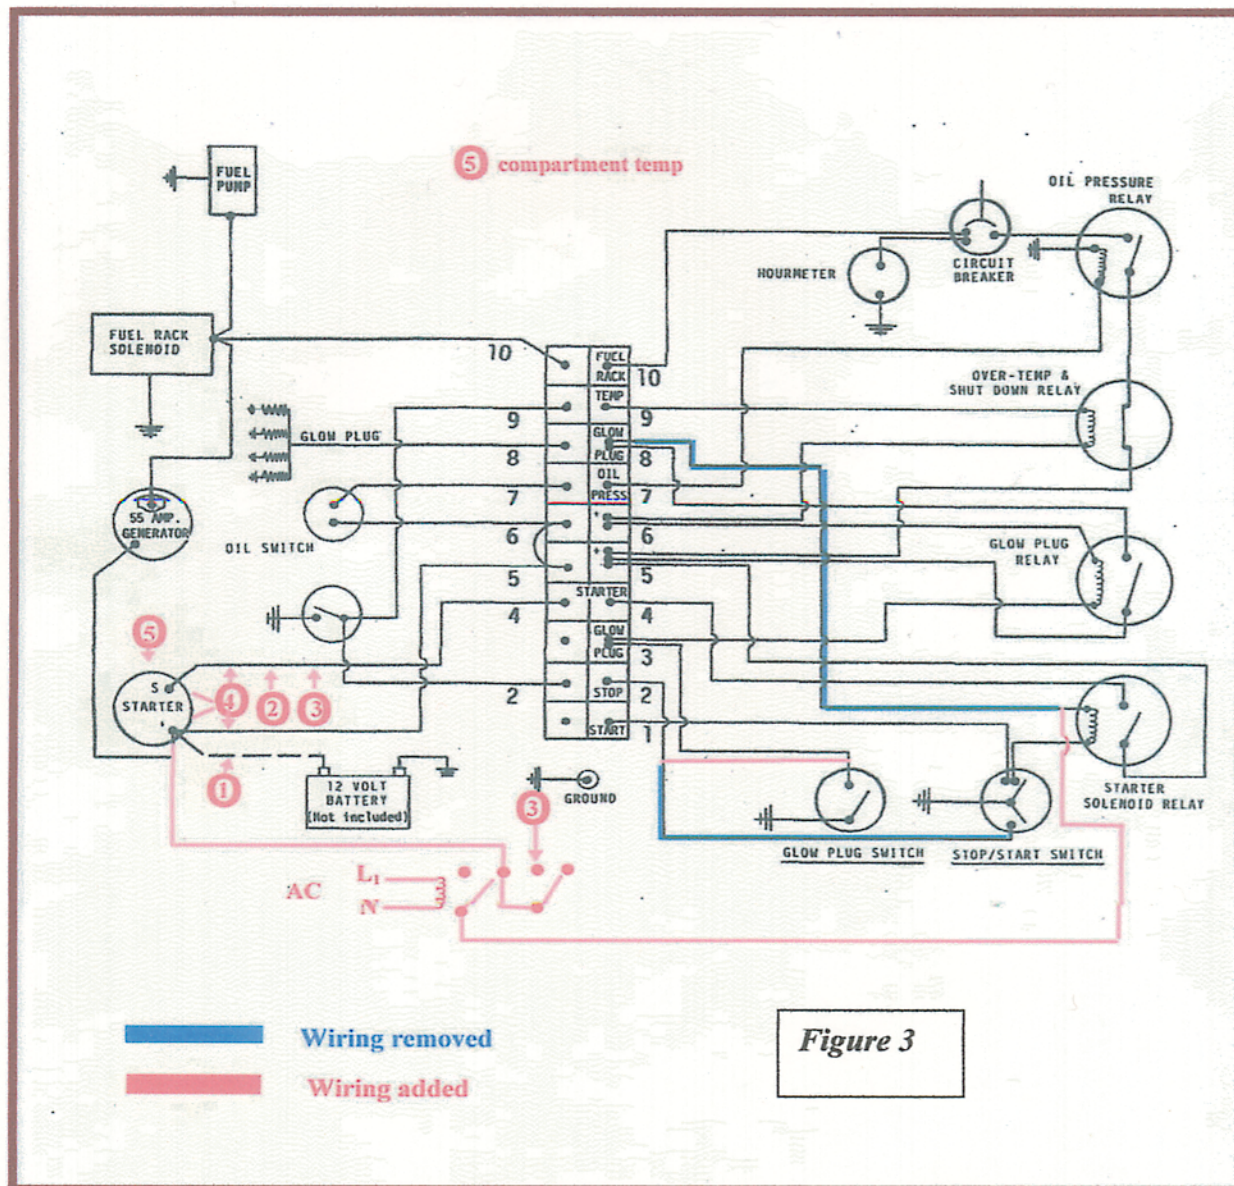
protection devices referenced above, it seems that additional protection may be afforded by the options listed below with locations shown on Figure 3.

Option 1: Use a latching solenoid for powering and de-powering all generator circuits. This manually disables the autostart function and the generator.

Option 2: Place a low amperage fuse in the B+ line to the solenoid. I believe this is a standard protection device in marine applications.

Option 3: Use a wiring protocol that permits B+ to the starter solenoid relay only under limited circumstances such as only when the glowplug relay is activated. Alternatively, use a starter lockout relay that locks out any B+ to the solenoid whenever AC is being generated. In both cases a sticking relay could still cause problems.

Option4: Use a Klaxon type of thermal switch on the starter. This option will prevent extraneous B+ to the starter solenoid from causing starter run-on once the starter case becomes heated. However, it will not prevent starter run-on if the solenoid contacts become fused. To eliminate this rare possibility, the Klaxon can be interfaced to a circuit which will trip the latching solenoid supplying B+ to the generator, thereby cutting power to all generator circuits, including the starter.

Option 5: Use thermometers to monitor the temperature of the generator compartment and the starter case.

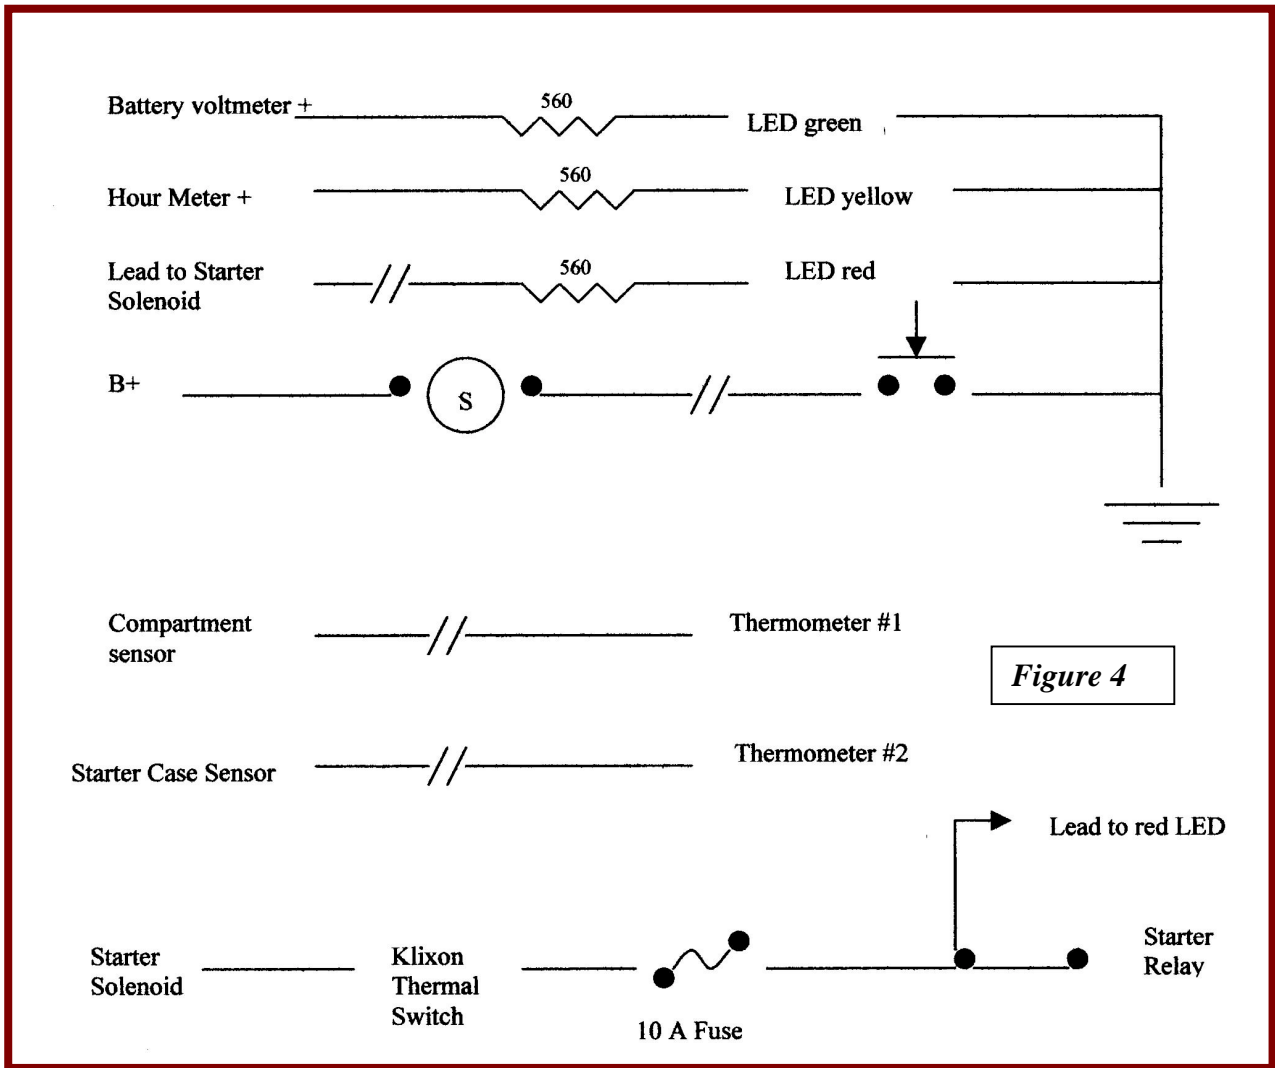
Figure 4 shows the location of circuits for diagnostic LEDs, thermometers, and an ON/OFF latching solenoid for 12V supply. On our coach, a red LED indicates the starter is cranking, a yellow LED indicates the generator is running and AC

is being produced, and a green LED indicates that battery power to the generator is enabled.

Modifying the wiring to add the new circuits will vary in different vehicles. However, in most cases, existing wiring will be modified on the generator, at the generator battery, in the generator control box, and at the remote panel inside the coach. New wires will be added between the generator compartment and the interior control panel. The LEDs, resistors, the momentary switch, and the thermometer display are installed on the control panel. The latching solenoid is installed next to the generator battery on the positive line out of the battery and after the auxiliary start solenoid (jump-start or booster solenoid), if so equipped. The new momentary push-button switch on the control panel controls the latching solenoid. The Klaxon is installed directly on the starter case and held in place with a wire or nylon strap. The existing battery cable supplying the starter is moved to one terminal of the normally closed solenoid and a new cable is installed from the solenoid to the starter. One temperature sensor is installed on the starter case and the other is installed in an appropriate location to monitor ambient air temperature.
